Turning Basaltic Terrain into Model Research Farm: Chronicle Description

ICAR-National Institute of Abiotic Stress Management
(Indian Council of Agricultural Research)
Malegaon, Baramati - 413 115, Pune

Feb, 2015

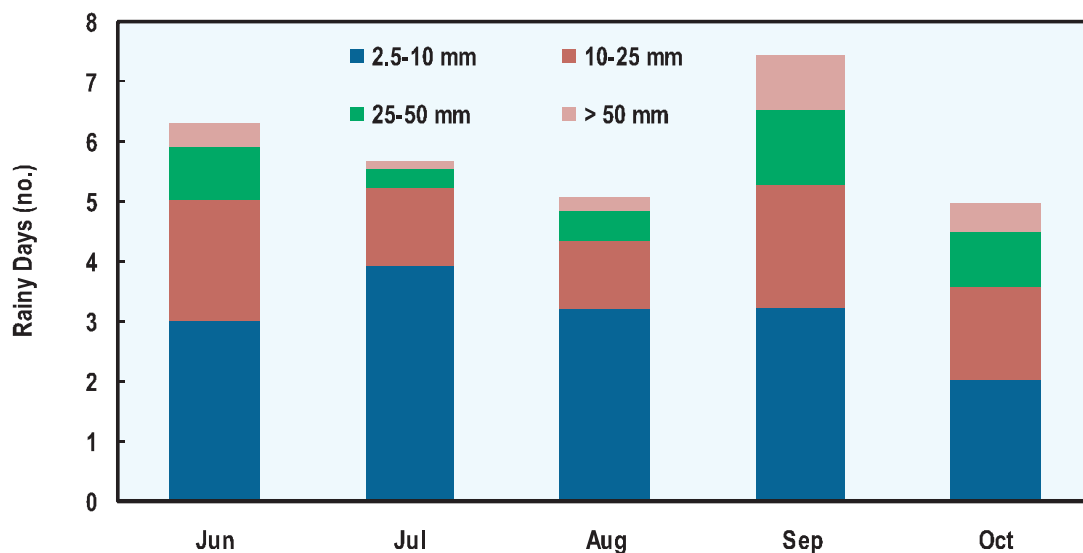
Fig. 2. Normal rainfall intensity distribution in various rainy months

The average number of days with rainfall > 2.5 mm range between 5 -7 during the June to October. However, the heavy precipitation events occur more during September, June and October than July and August which result in lesser total rainfall during the later months (Fig.2). SW-monsoon rainfall is showing a slight increasing trend ($R^2 = 0.15^*$) while no trend was

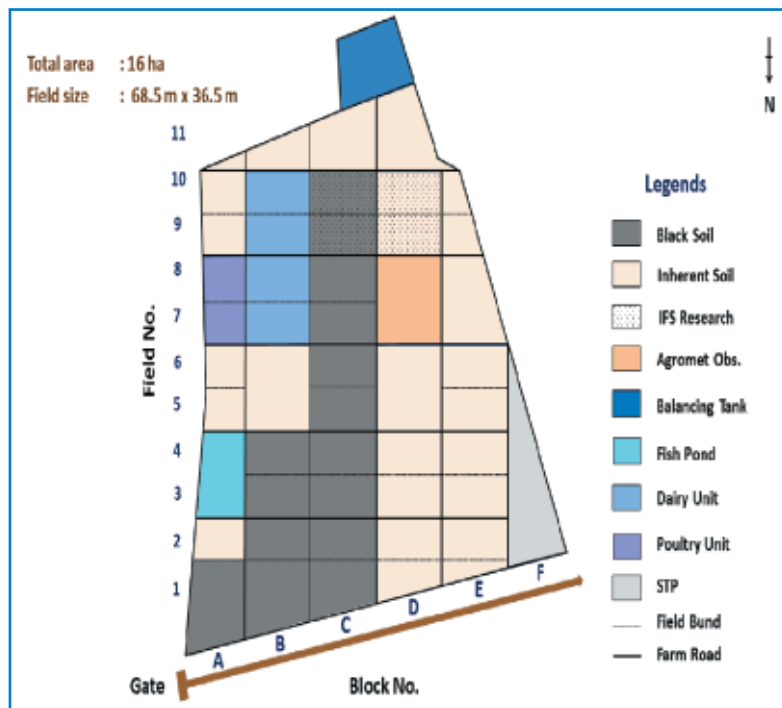
Fig. 6. Layout plan of the south side farm

Considering the above points, it was decided to create 32 research plots (Fig. 6). Central plots have regular rectangular shape whereas peripheral plots have trapezoidal or triangular shape constrained by the boundary wall. Central square shaped plots have roughly an area of 0.50 ha (68.5 m x 72.5 m). There are farm paths running all around these plots. Some plots, especially those on the west side with steep slope as indicated by closeness of contour lines and those filled up with black soil, were further bifurcated (68.5m x 36.5m; ~0.25 ha) by a field bund in order to reduce cost of filling/levelling. Thus the total number of research plots so generated in five longitudinal blocks now equal 37.

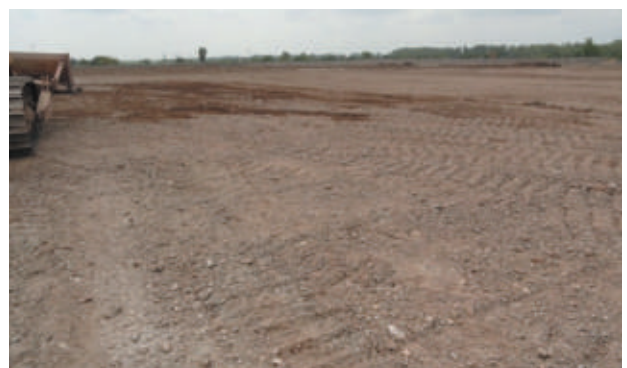
Levelled, ripped and chained field

Fig. 7. Ripping, chaining, boulder removal and levelling of the site for farm development

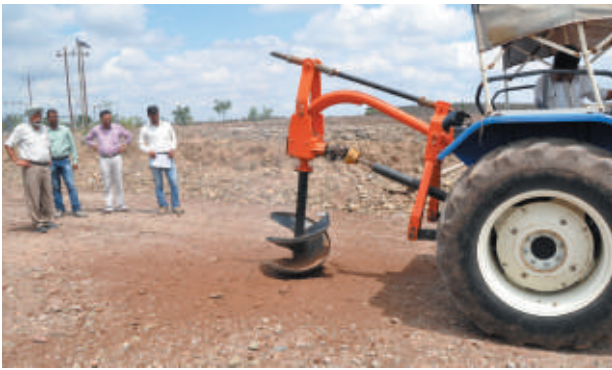
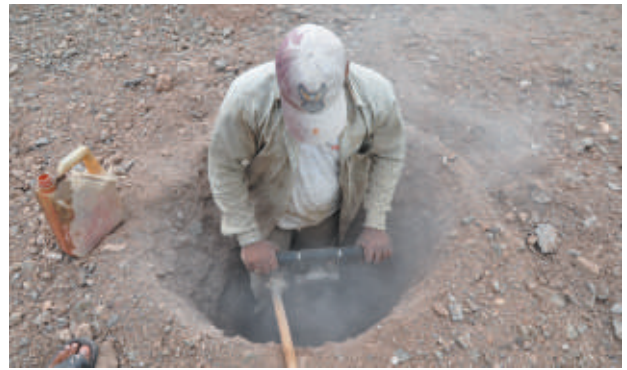
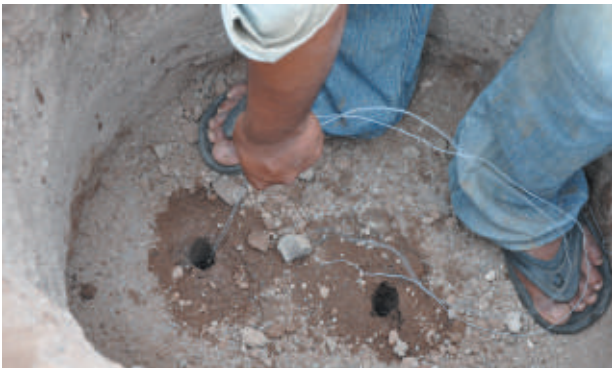
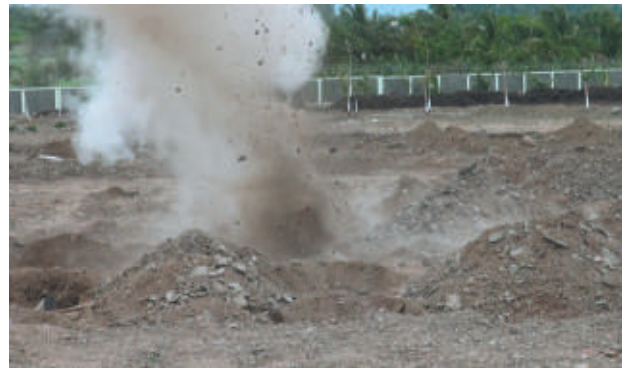
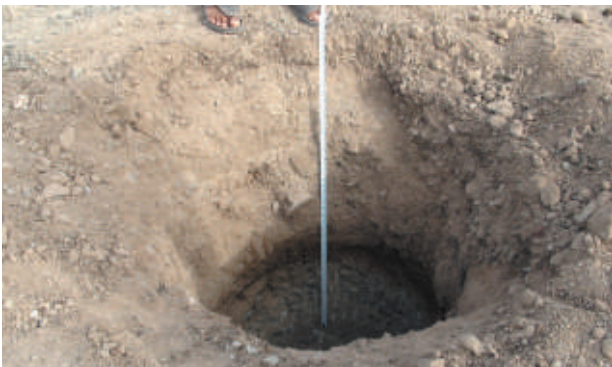
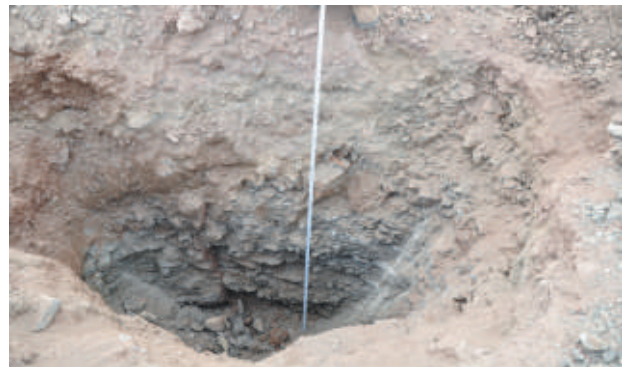
Fig. 17. A unique sub-soil water conservation technique being tried for sustaining orchards

minimise the supplemental irrigation requirements (Fig. 17). Similarly different volumes of rhizo-sphere (auger, pit and trench)

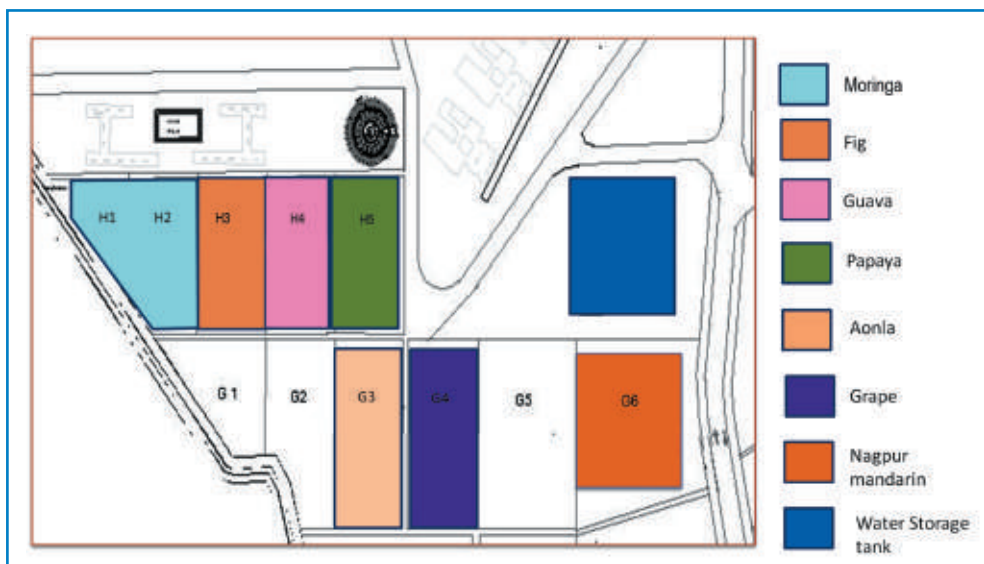
Fig. 18 Layout of orchard crops on north-west side

been developed into two block having 7 experimental plots with average riser height of 1 m and a run-off water recharging tank in the lowermost western end (Fig.18). The steps followed for their development were the same as enumerated for south-farm. Different orchards (Table 5) have been planted following the same procedures as listed for north-east terraces with the objectives of identifying the suitable planting techniques and filling mixtures to obviate edaphic stresses in orchards grown on shallow basaltic soils and optimising irrigation schedules for drip irrigation in orchards and the role of deficit irrigation/partial root zone drying in orchards; evaluation of the role of high water retentive and fertile black soil in defining water requirement and elucidation of physiological manifestations and drought tolerance in orchards (Fig.19). However, another concept being tested for Nagpur Mandarin is to enlarge rooting medium by pushing the surface soil for creating raised beds of 0.6 m height, 1.5 m surface width and spaced at 4.5 m. The trenches (0.3 m deep) so generated between two beds would be utilised for storing run-off water.

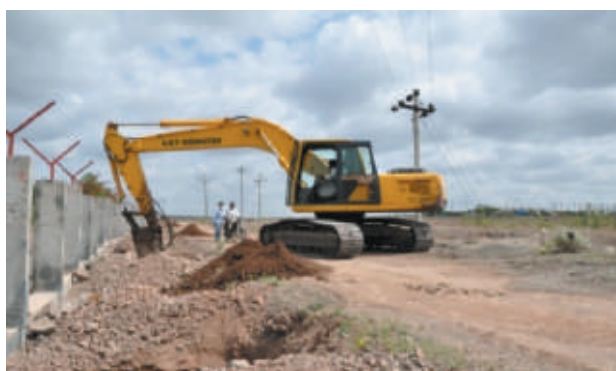
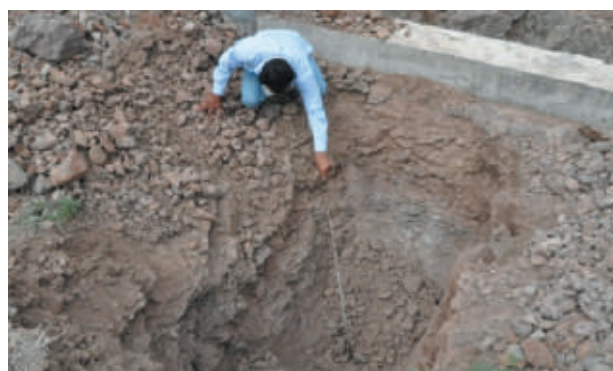
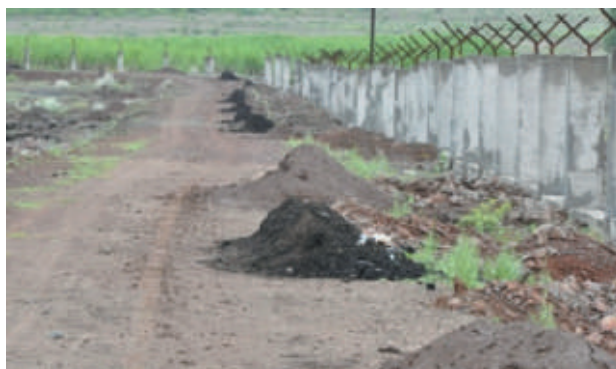
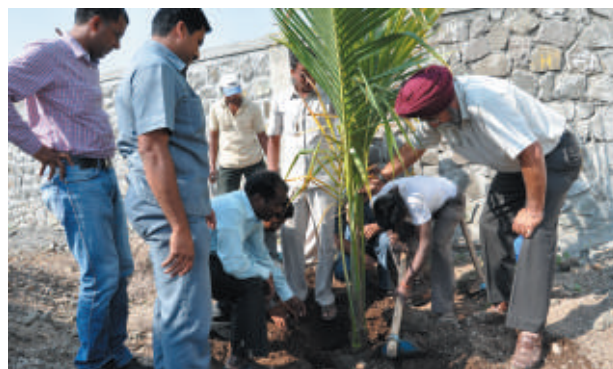
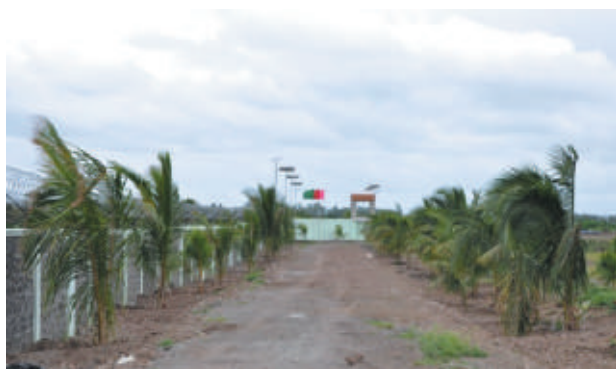
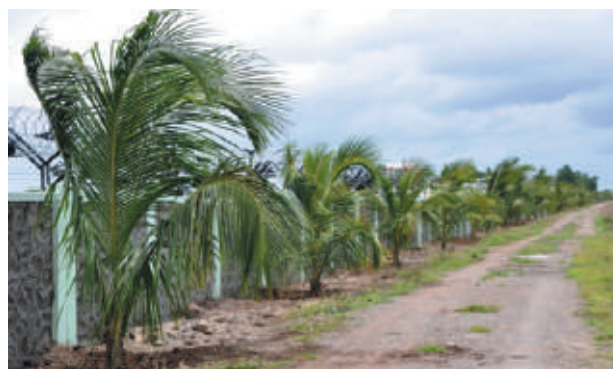
Fig. 20. Views of various steps in boundary plantation of coconut

(Banawali (WCT)) was planted all along the boundary with the plant to plant spacing of 9 m. Before planting, pits (1x1x1 m³) were dug using excavator machine, another 1 m depth of hard pan was loosened using breaker to facilitate better root penetration/development for coconut. Breaking of hard layer was carried out even in the top 1 m due to the presence of hard stones and boulders in all the pits. These were filled up with mixture of 1:1:1 of parent soil:

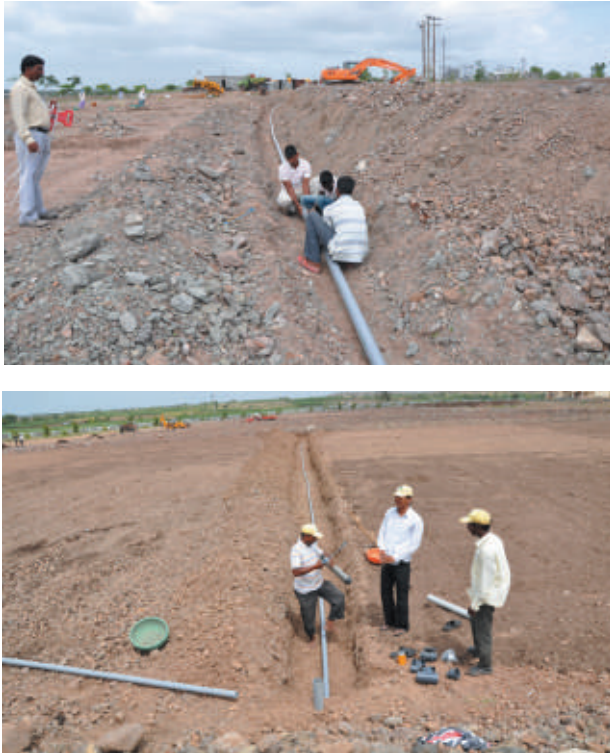
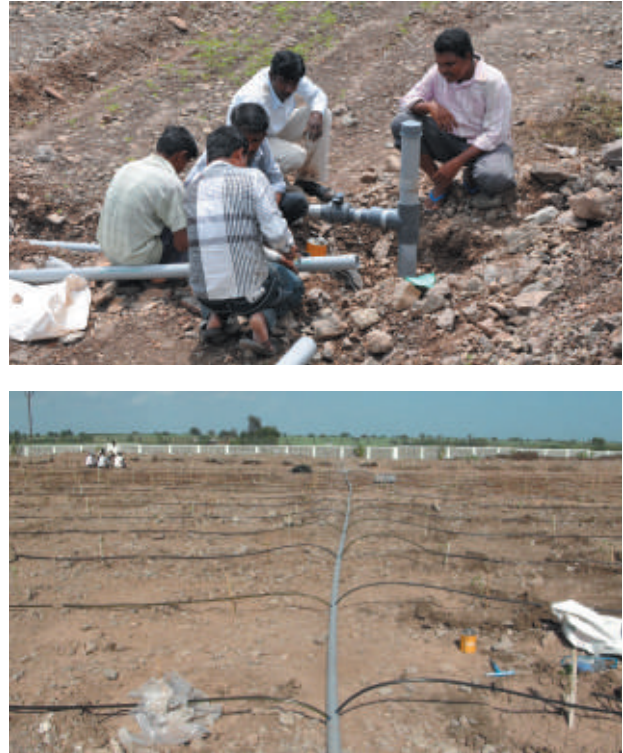
Fig. 23. Installation of drip irrigation system in north-east farm

losses. The present layout of the irrigation network for these orchard crops comprise of the 90 mm PVC pipe as main pipe, 63 mm PVC pipe as sub main and 16 mm LDPE laterals (Fig.23).

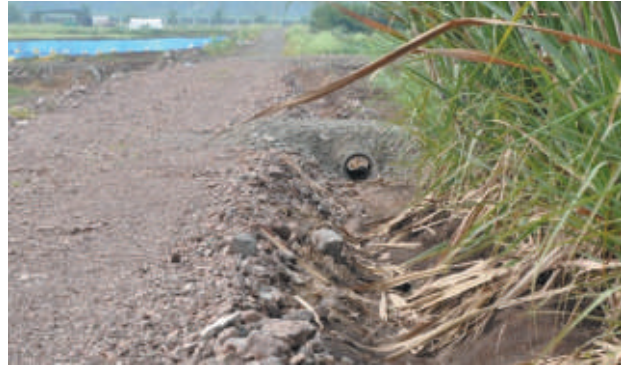
Runoff water channeled to the depression area (north-west side)

Fig. 24. Drainage network and runoff water collection sites

drains (Fig. 24). Furthermore, these sub drains carried the excess water to nearest storage pond through main drain line. For the design of drains, various parameters such as velocity of run-off water, discharge rate and bed depth were considered to prevent any scouring of farm paths as well as plots. Cement pipes of 150-450 mm diameter were laid for crossing paths and bunds wherever required. Semi-circular earthen drainage ditch of 0.5-1.0 m top width and 0.3-0.5 m depth was constructed inside peripheral boundary road to collect all the runoff water to the three water harvesting ponds on three sides of the land.

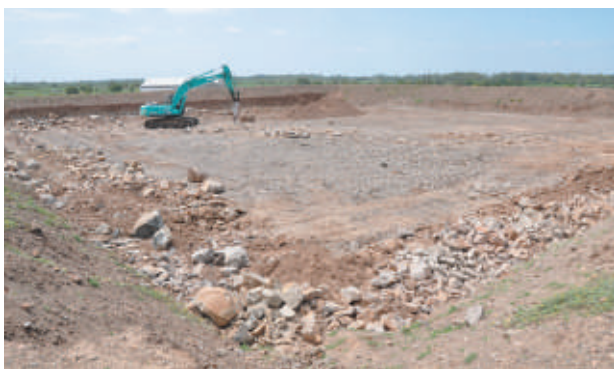
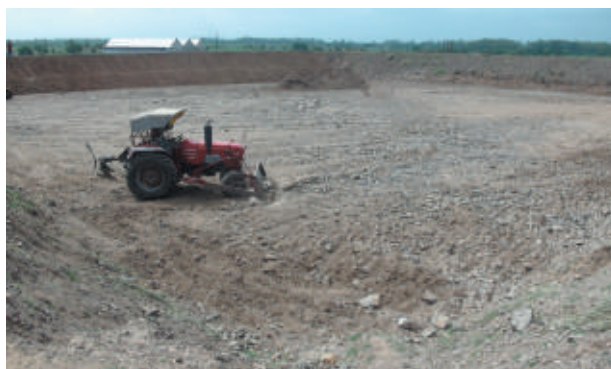
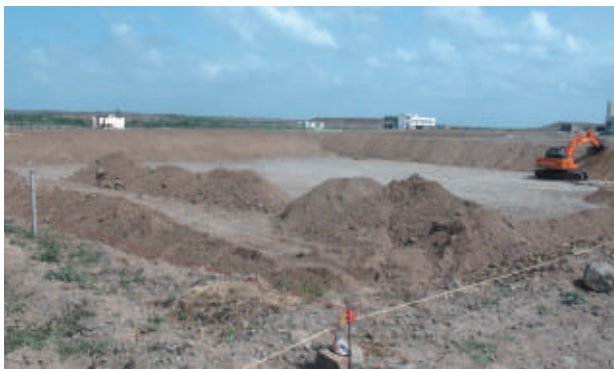
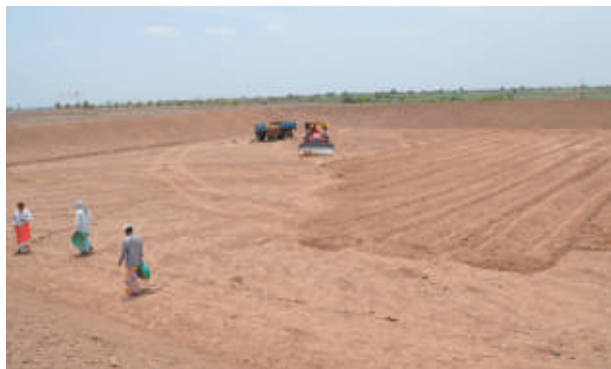
Fig. 29. Construction of water balancing tank in northern side

table top surface and pond layout was demarcated. About 55% loose materials (577 m³) like *murum* soil and loose stones were excavated stepwise through front loader and back hoe bucket dozer (JCB 75 hp) and transported for road and field plot preparation. The remaining 45% parental hard rocks (473 m³) were removed by the ripping through heavy

dozer and micro blasting. Unbroken hard rock material was breakdown into smaller size by chaining operation of heavy dozer so that it can be utilised as filling material for the farm road preparation. After achieving the 3 m bottom depth and natural slopes (1:1) bottom floor and slanting sides was fine levelled through the poclain machine (210 HP) with breaker and bucket mechanism. Thereafter about 200 brass of black soil with 15 cm was applied as cushion material before installation of pond lining material i.e. HDPE sheet of 600–1000 GSM size. About 5600 m² bottom and side area was covered with HDPE lining sheet material for avoiding the seepage losses. The inlet and gravity outlets each of 15 cm diameter PVC pipe
